## 1. General data on the vessel

| Model: | 27 SPORT |

## **2. Approach to the inspection**

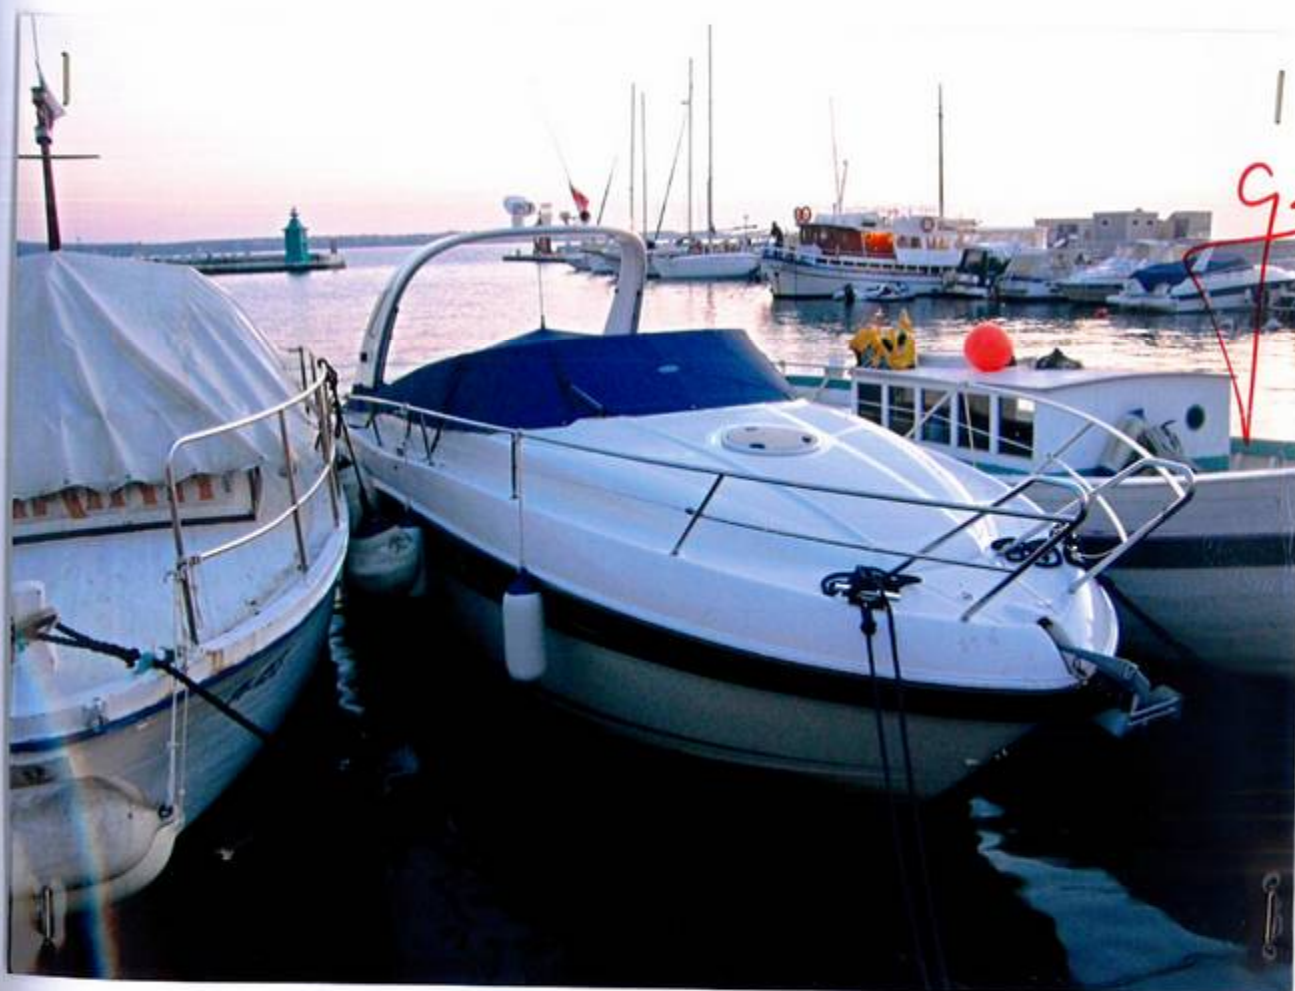
2.

The inspection starts with the examination of the external part of the vessel. Deck surfaces are examined and no visible traces of any damage or repairing works can be noticed on them. The surfaces are in good order and show a good standard of maintenance. The underwater hull surface is covered with fouling material and appears to need maintenance works. There is a blue painted line on the hull surface from bow to stern; its surface is shiny and with no traces of any damage (enclosed picture N. 2). On the bow, a bruce anchor, cca. 10 kg, and a

The whole cockpit is covered with a protective impermeable blue canvas which appears to be in good order as there are no repairing works observed (enclosed picture N. 2).
